# Repairing Dolce Gusto Melody Water Seal

Showing how to repair the leaking water from the bottom of the machine caused by a dirty water seal near the bottom of the water tank.

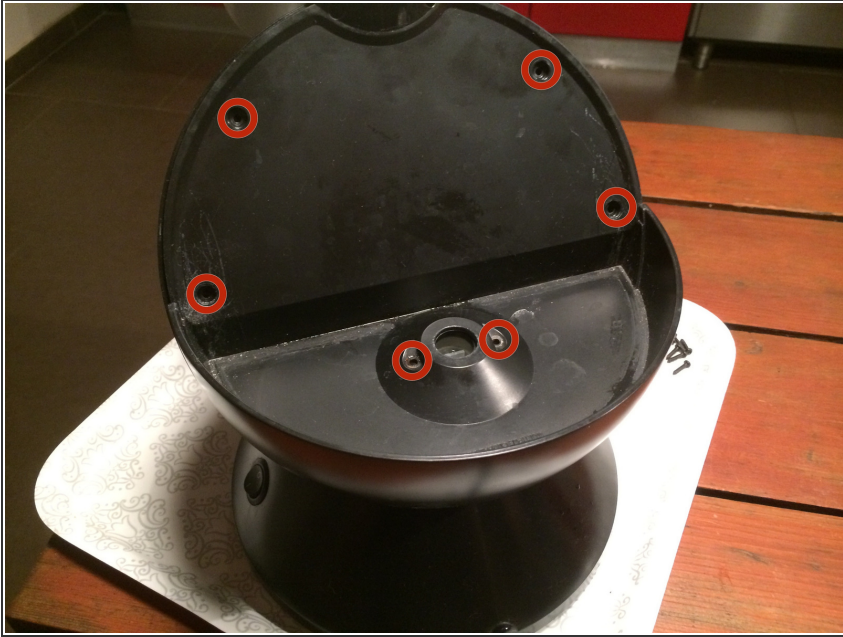
## Step 1 — Repairing Dolce Gusto Melody Water Seal

- Remove the 6 screws from the back.

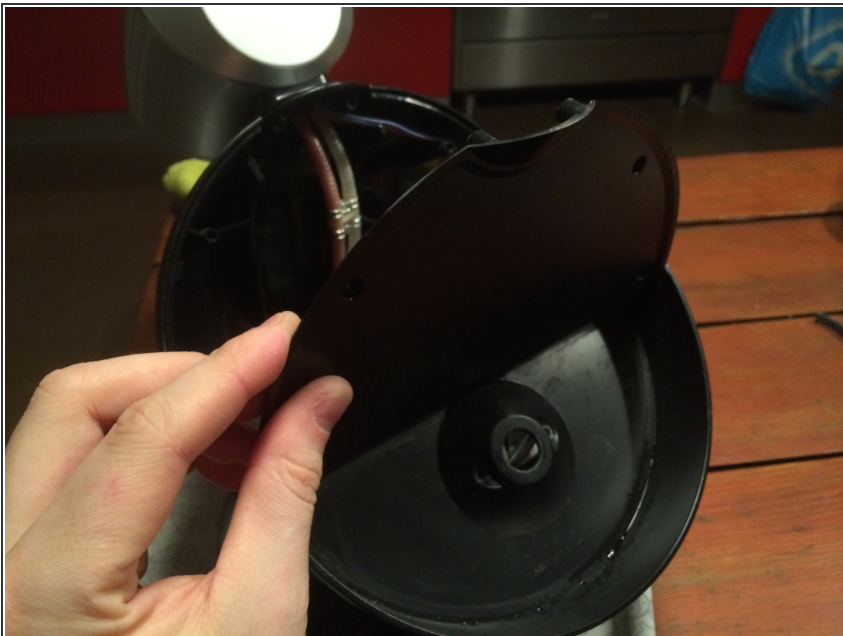
## Step 2

- Gently pull at the top of the rear cover.

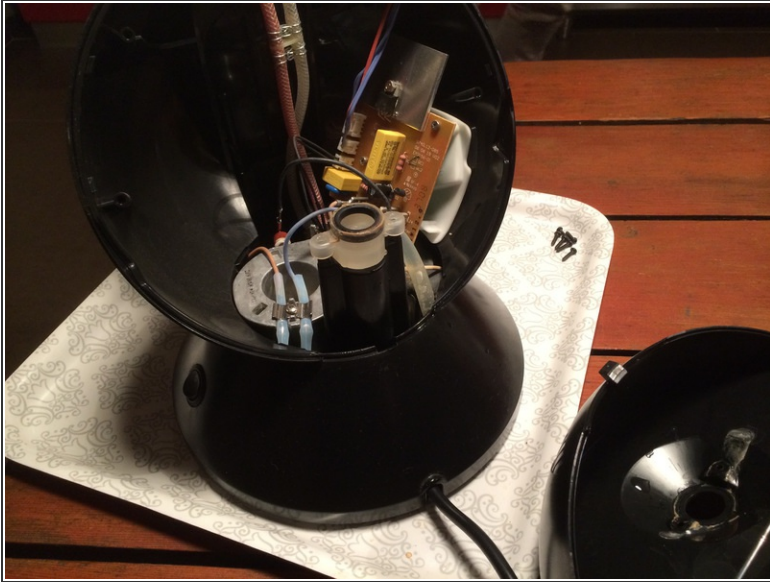
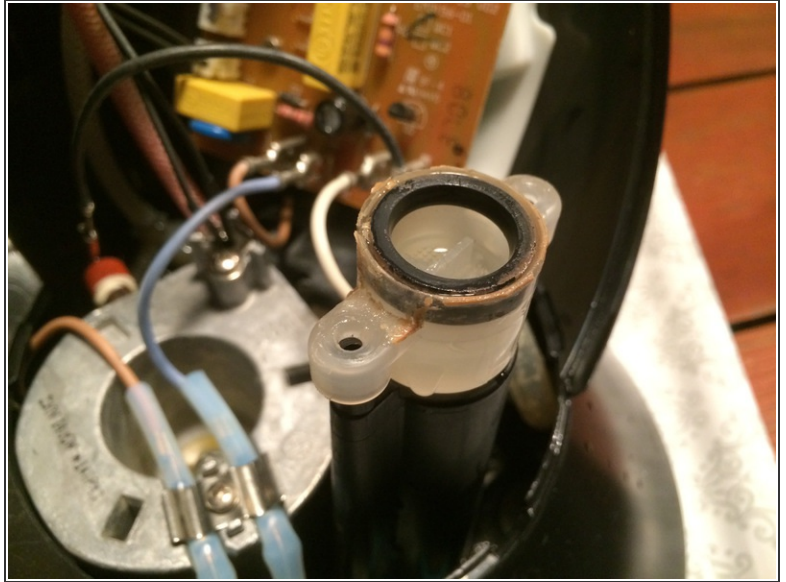
### Step 3

- Locate the dirty seal inside

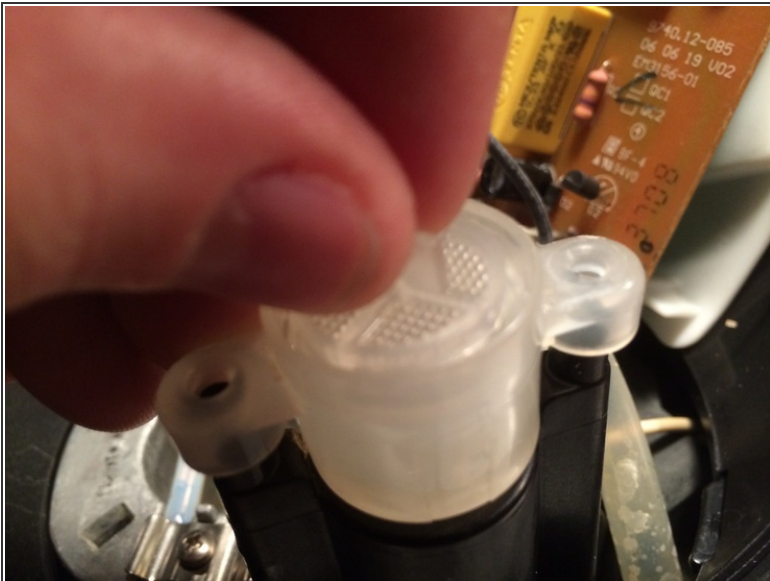
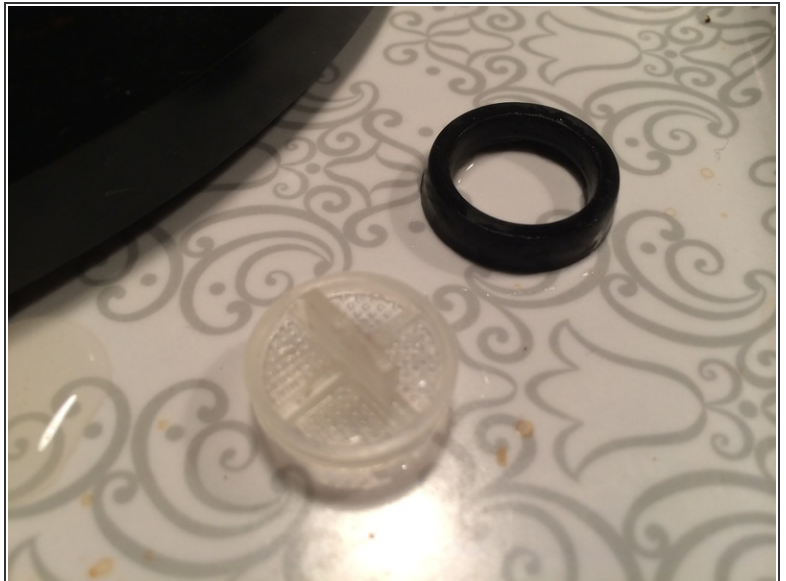
### Step 4

- Pull out the rubber seal and the filter.

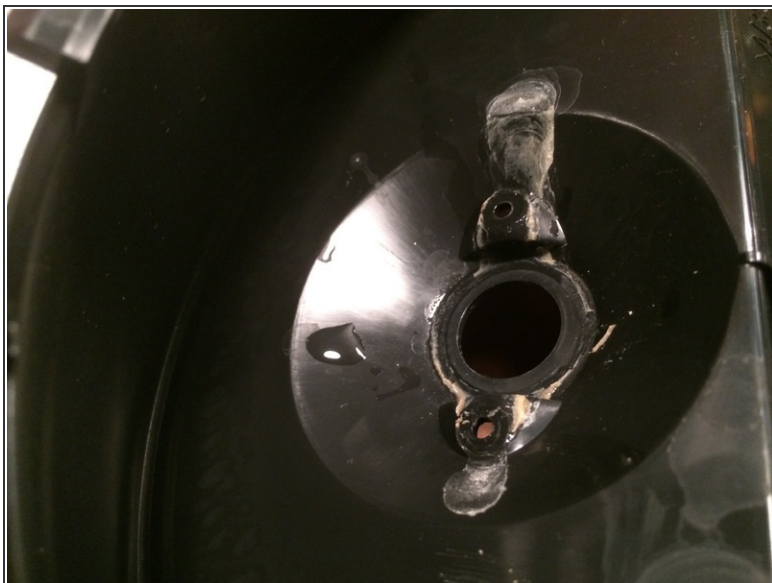
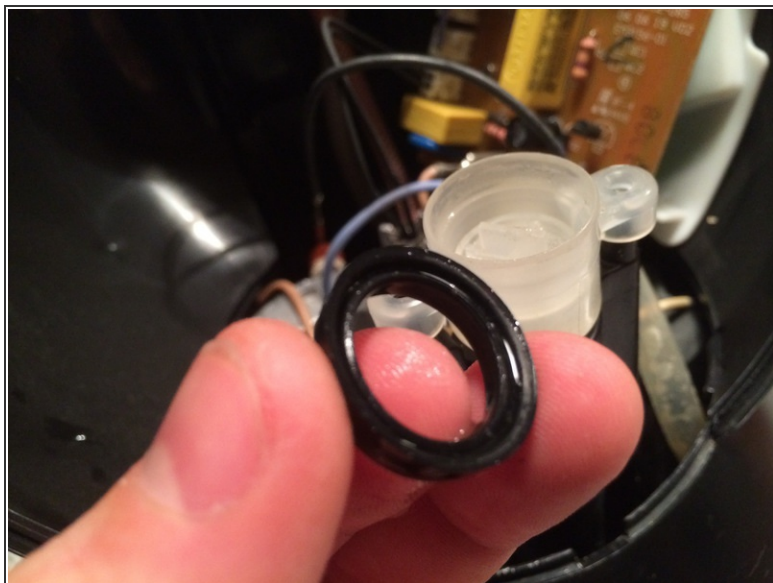
## Step 5

- Clean the inside of the cover, the rubber ring, the filter and the holder of the rubber and filter.

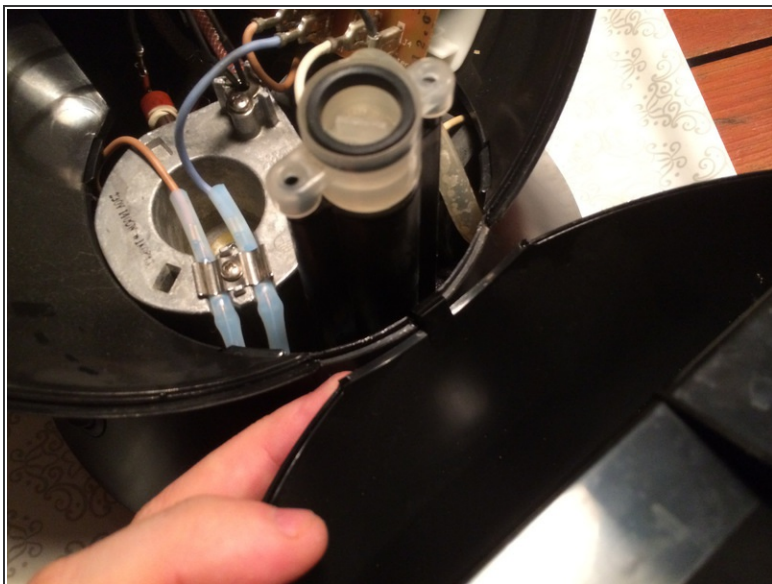
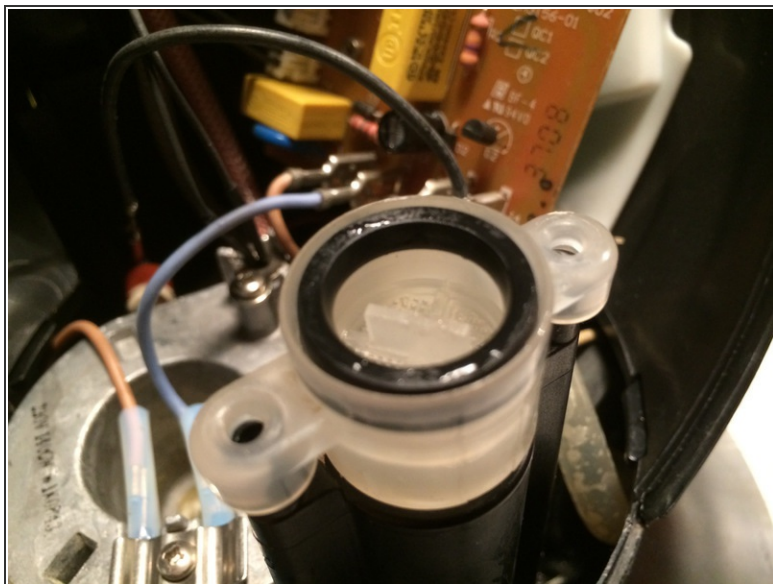
## Step 6

- Put it all back together... First the filter, then the rubber ring... You need the smooth side of the ring facing up.

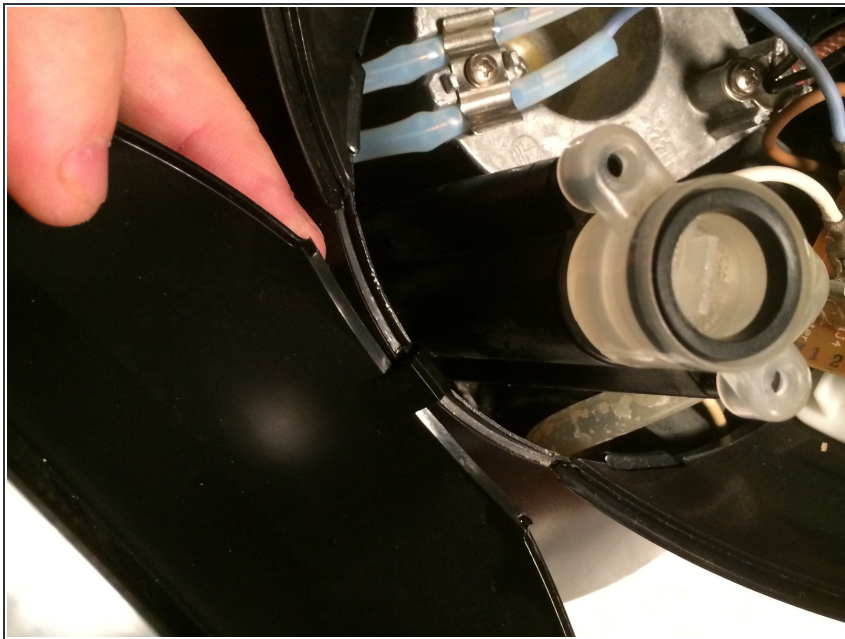
## Step 7

- Hook back in the back cover, be careful not to break the clip at the bottom

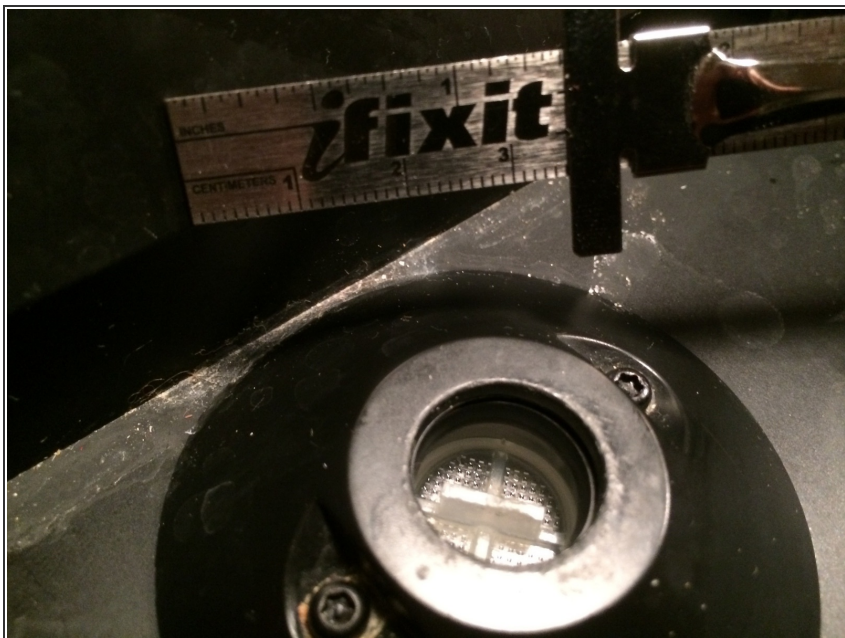
## Step 8

- Back together... And you are ready to make some coffee...

In case you notice the water seal rubber is broken or has tiny cuts in it. You can re-order part: MS-0907124 - Krups Seal
